Inspection Report

Minerals Regulatory Program

Mine Name: Munchkin 1-2-3	Permit Number: S0010066
Operator Name: Earth's Partners LLC.	Inspection Date: 07-22-2008
Inspector(s): Tom Munson & Brett Gregory	Time: 5:00 pm
Other Participants: None	Mine Status: Active

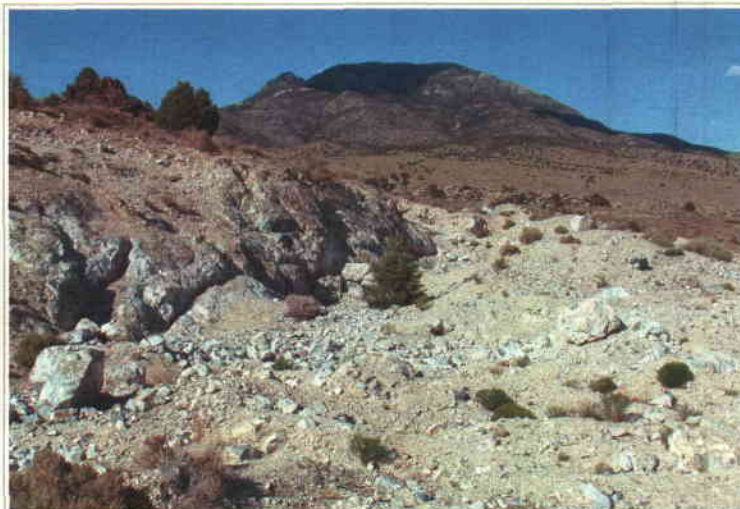
Visible growth, old pit.

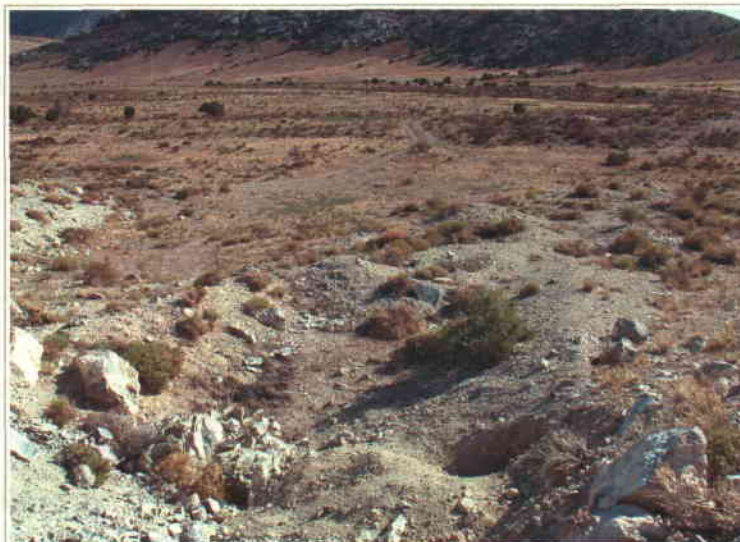
Another disturbance.
